# ACCESS BARRIERS ENCOUNTERED BY PERSONS WITH MOBILITY DISABILITIES IN ACCRA, GHANA

The environment is a critical factor for participation for everyone. The need for accessible transportation and built environment for persons with disabilities to enjoy their basic human rights and fundamental freedoms cannot be overemphasized. This study sought to understand the daily experiences of persons with mobility disabilities with physical and transportation barriers in Accra-Ghana. Photovoice methodology was used to enable participants to tell their stories about access barriers that they encountered daily. A total of 153 pictures remained, out of 431, after the final selection of pictures that best communicated participants' experiences with accessibility. These pictures were accompanied with 95 narratives corresponding to the content of the pictures as well as the messages that the participants sought to communicate. The pictures were taken from 11 different physical and transportation environments. Evidence from the study demonstrates the existence of barriers in the built environment and transportation, which impact negatively on the psychological and social lives of persons with mobi

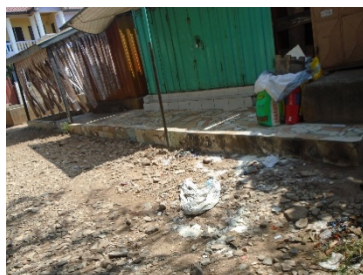
**Figure 1: Rocky Pathway**

**Inaccessible Path/walkway.** Walkways connect to main roads, but the pictures of walkways taken in this study were mostly muddy, rocky, hilly, and sandy; others had potholes which were waterlogged after rains. The nature of these walkways obstructed the movement of participants. While some participants, especially those using crutches, reported having fallen several times managing these barriers, others said they were hurt from the falls.

*This is the pathway from my house to the bus stop and the salon. The road is very rough and difficult to walk on. I have fallen there several times. So, I have learnt to be very careful whenever I use the road. Regardless, I still fall, and anytime I fall, I feel very bad because everybody falls at a point in time in life, but whenever I fall, I feel very different because people stare at me and feel pity for me. I would be happy if the path is tarred or levelled to avoid all of this. (AF10, female, uses crutches).*

*I use this pathway regularly from my house to the main streets to continue my journey to wherever I choose to go. It is rough and rocky and difficult for me to use. The nature of the pathway obstructs my movement and sometimes makes me fall. I have fallen not once or twice, but countless times. When it happens like that, I look at my surroundings to see if anyone is looking at me. It is shameful when that happens. One day, the fall resulted in an injury. I went straight home, cleaned the wound and took care of myself. I couldn't complain to anyone. At that moment, I felt bad that even the road that I COULD use is rough. To me, it means everything around me is not working. (SA3, female, one leg amputated).*

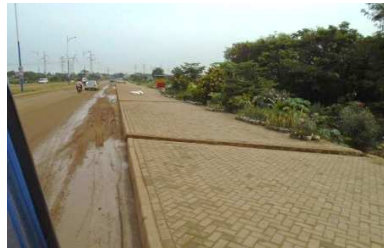
**Figure 2: Inaccessible Sidewalk**

**Sidewalks.** Sidewalks are useful for the safety of pedestrians and allow for their free and easy movement. They also allow the free flow of traffic when pedestrians use them because they will not crowd the roads. Sadly, the study discovered that sidewalks were virtually non-existent. The few existing sidewalks were not thorough. For example, in certain cases a sidewalk began at one side of the road and ended in the middle of the road, while another began from the middle. It is worthy to note that the majority of the sidewalks did not have curb cuts, making it difficult for persons with mobility disabilities to access them. In addition, evidence from the study indicated that the few existing sidewalks were broken, inhibited with obstacles such as poles, gutters and potholes while others were very rough to use. All of these compelled the participants to use the major roads, endangering their lives as captured in some of photo captions, "My life matters," "It's over" and "Where should I pass?" See figure 2 relates to the caption "Where should I pass?" and the narrative below it expresses the participant's feelings.

*This pavement is on the road from under the bridge in Ashaiman. As you can see, there are several gutters in it, making it difficult for me as a wheelchair user to use that road. I mostly use the major road regardless of the safety concerns. But when it rains, even the major road presents a much greater challenge and becomes unmemorable, crowded with sand. I remember when they were working on this road, I personally took it upon myself to talk to the contractors to ensure that the pavement would be accessible but they did not mind me. I feel worried that I could be knocked down by a car one day while using the road. This road is the major route from my house to the bus station. But because of this barrier, I do not go out a lot. (MD1, female, uses wheelchair).*

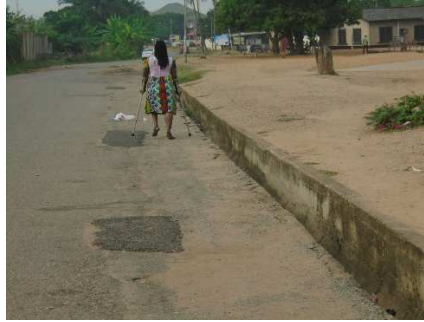
**Figure 3: Uncovered Gutter**

**Open Gutters and Split Covers.** Closely related to inaccessible pavements are open gutters and drainage systems noted to be a huge challenge to everyone in Ghana. Anecdotal evidence indicates the existence of many uncovered gutters, which were also captured in this study. Open and semi-covered drainage holes were also identified in this study as barriers to physical access. An interesting finding regarding the drainage system in Ghana is the use of split metal to cover gutters. Participants, especially those using crutches and wheelchairs said that they were sometimes trapped by those covers. Crutches and front wheels of wheelchairs got stuck in the splits, causing falls and hurts to users of these assistive devices. One participant narrated his order trapped in a split metal cover (see figure 4 below) as follows:

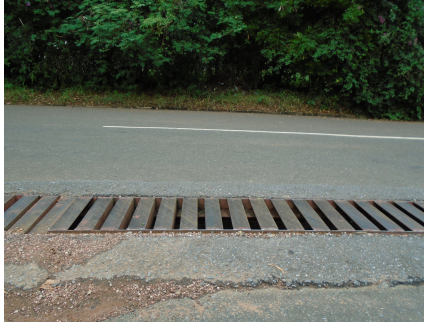
**Figure 4: Split Metal Cover**

*One day, I nearly lost my life on my way to write an exam. When I got to this split metal drain cover, the front tire of my wheelchair got stuck in there and I lost my balance and fell out of my wheelchair. You can see that the entire area is rough due to the broken pavement. I hurt my arm but I couldn't go back to the hall to rest because I had to go and write a two and a half (2 ½) hour exam. In fact, I wrote that exam with so much pain which lasted beyond the exam time period. Sometimes, I had to pause and relax the arm to ease the pain before continuing. I felt very humiliated because many people were passing by and I had to crawl from the ground, like a child back into my wheelchair. (SM 7, Male, uses wheelchair).*

The study sought to explore physical and transportation access barriers that persons with mobility disabilities experience daily in the Accra Metropolis using a photo voice methodology. Participants identified the existence of environmental barriers beginning from the homes of participants, through their surroundings and means of transportation to their destinations. The barriers were classified as *physical barriers* or *transportation barriers*. Physical barriers are further grouped under surroundings of environment, entrances to buildings and inside arrangement of buildings. Inaccessible pathways, sidewalks and open gutters restricted access to the surroundings of participants' environments, validating other African studies (Badu et al., 2016; Banda-Chalwe & De Jonge, 2013; Vergunst et al., 2015). The study outcome also indicated that split covers impeded access for participants.

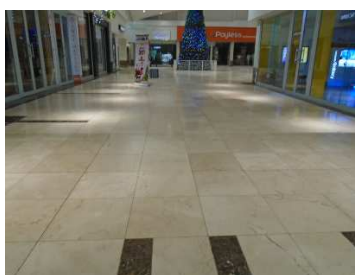
**Figure: 7 Smooth Tiles**

Another challenge that relates to stairways, steps and ramps is the use of smooth and slippery tiles to beautify edifices. Smooth tiles were captured almost everywhere in the study environments (see figure 7). Smooth and slippery tiles were identified as a major access barrier because they could be slippery even without water, hence, water could worsen the situation, especially for those who use crutches. Such persons could easily fall when the grips of their crutches (usually rubber grips) come into contact with slippery smooth tiles. Due to these inconveniences, persons with mobility disabilities who used crutches were sometimes compelled to allow themselves to be carried into buildings.

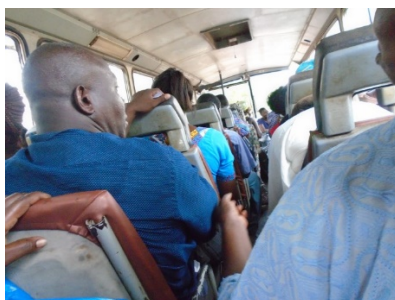
**Figure 11: Inside of a Trotro**

Closely related to the entrance of buses are the small aisle spaces which were mostly crowded and difficult to access (see figure 11). The seating arrangements are such that there is not enough room insides buses/trotros for persons with mobility disabilities.

Crowded aisles and seating arrangements which do not allow enough room for persons with mobility disabilities were identified by the participants as issues and were reported to have caused fatigue and ill health for some of the participants as expressed in the narrative below. Front seats of buses and minibuses, mostly spacious, are typically occupied by able-bodied people who race ahead of persons with disabilities to occupy such seats. Although Section 29 of the Persons with Disability Act (715) requires that two seats are reserved for persons with disabilities in every commercial vehicle, this requirement is yet to be adhered to.

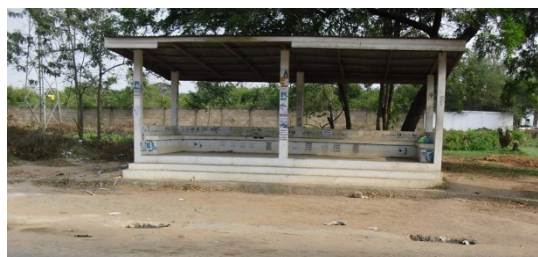
**Figure 12: Inaccessible bus stop**

Many bus stops, located in inconvenient places, were mostly not accessible to persons with mobility disabilities. The bus stops lacked curb cuts to enable persons with mobility disabilities to use sidewalks/stops to avoid the danger of being run over by buses or motor bicycle riders. In addition, some of the bus stops did not have shelters and those which had shelters were not accessible due to steps. This raises the question of what persons with mobility disabilities would do when it rains or when the sun is hot, given that they usually wait in transit for longer times. Also, drivers usually did not pay attention to where and how they parked for passengers to board their vehicles. Some parked at places not designated as parking spots. All of these impact on the safety of persons with mobility disabilities.

With regards to transportation environment, the study cites inaccessible bus stops and stations which were also reported by Bezyak, Sabella & Gattis (2017) in the United States but the authors did not specify what the exact barriers were. Inaccessible bus stops from this study arise from the lack of curb cuts to use sidewalks. Also, absence of shelters or inaccessible shelters raise the question of what persons with mobility disabilities would do in the event of unfavourable weather conditions such as rain or extreme heat from sunlight, given that they usually wait in transit for longer periods. Buses parking at inconvenient places and locations and overly short timing for pedestrian crossing at traffic lights were also identified as barriers to accessibility by participants in this study. Further, the study suggests that some drivers did not yield for pedestrians when traffic lights turned green for pedestrians to cross.
