# THE ROLE OF MICROBE–METAL INTERACTIONS IN THE DEGRADATION OF EMULSION PAINTINGS IN PORT HARCOURT, NIGERIA.

## **The Role of Microbe/Metal Interactions In The Degradation of Emulsion Paintings of Buildings In Port Harcourt, Nigeria**

**Orij, O.G.<sup>1</sup>; Nartey, V.K.<sup>2</sup>; Brimah, A.K.<sup>2</sup>**

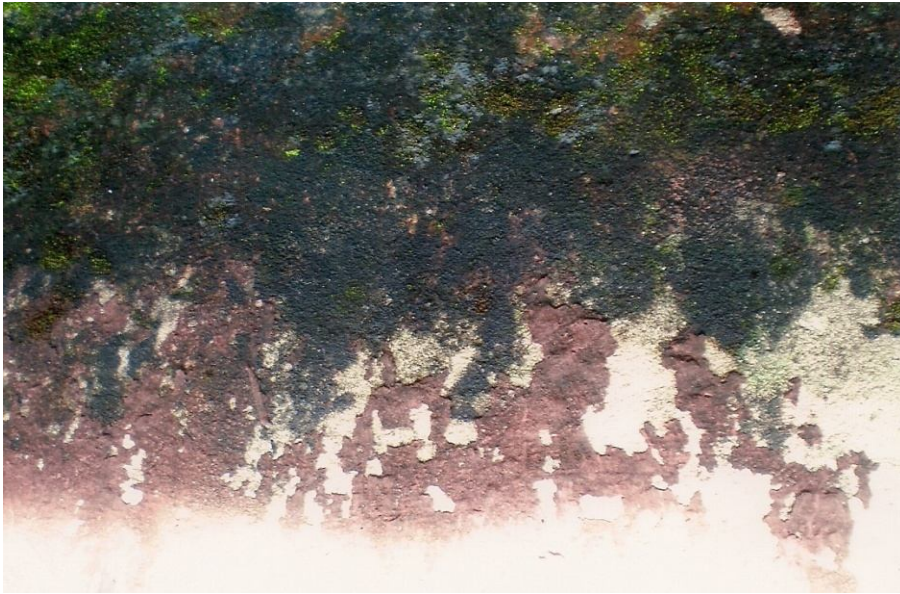
**Figure 1:** Plate 10 (A freshly degraded emulsion painting (infected wall))

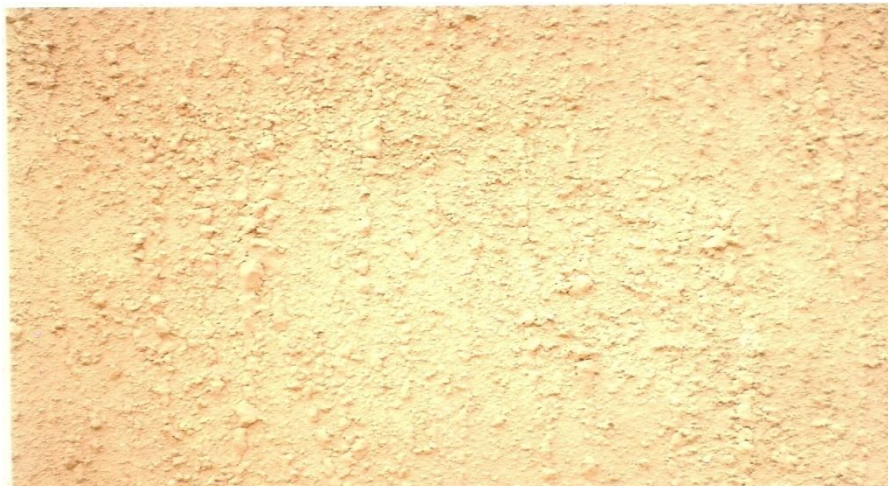
**Figure 2:** Plate 7 (An undegraded emulsion painting (good wall))

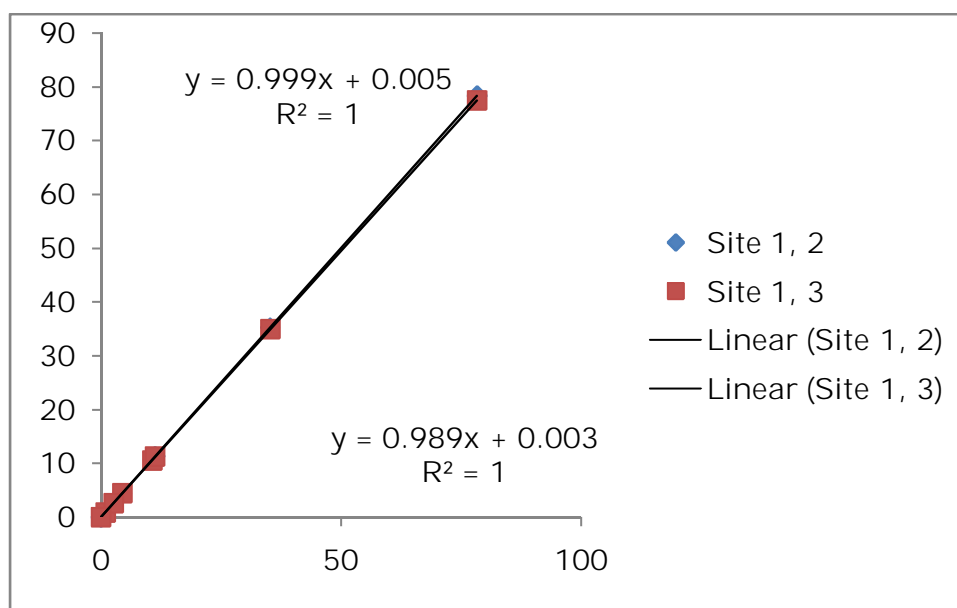
**Figure 3:** Graph of Correlation between Heavy Metal Concentrations in Degraded sites

The results here,  $R=1$  and  $R^2=1$ , for each correlation, show that there is a perfect linear correlation of the concentrations of heavy metals for the three sites in the degraded area. This means that as the concentrations of heavy metals increase in site 1 there is a perfectly corresponding increase of the concentrations of heavy metals in site 2 as well as in site 3. An interesting factor also is that the total variation in the values of the concentrations in all the three sites is predictable by the regression line for both site 1 and site 2 and between site 2 and site 3 as well as between sites 1 and 3. Just as it is in the degraded sites, there is a perfect correlation of metallic concentration in the undegraded sites as well. In this case, 99% of the total fluctuation is also predictable by the regression lines as indicated by the value  $R^2=0.99$ .
