RESEARCH ARTICLE

Examining change and permanence in traditional earthen construction in Ghana: a case study of Tamale and Wa

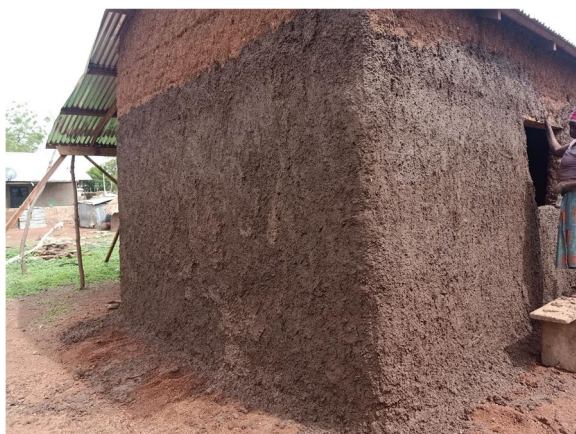
Fig. 2 It is the responsibility of women to plaster a newly constructed earthen building in Tamale (Source: the authors, taken in 2022)

Earthen construction is communal in nature. Local builders are commissioned to undertake the project, but male children, youth, and elders provide support by mixing, moulding, and carrying the cob to the builder. The elders guide the builder and homeowner to ensure that the layout follows the prescribed cultural practices. Women also prepare meals, fetch water for construction, and plaster the finished buildings (Fig. 2).

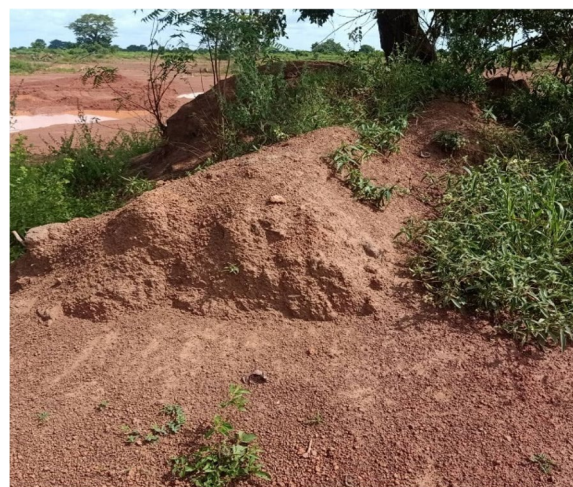
**Fig. 3** Sand mining pit in Jarigu, Tamale (Source: the authors, taken in 2019)

The survey respondents disclosed that they had trouble accessing building materials to construct their houses. They explained that they sometimes travel more than 10 km to neighbouring communities to cart laterite for construction. The researchers had the opportunity to visit one of the sand pits in Jarigu, approximately 12 km from Wamali, a peri-urban community in Tamale (Fig. 3). A

20-cubic-metre truck of laterite cost approximately GHS 1200 (\$100) in 2021. This quantity would be sufficient to construct two rooms with the cob construction method.

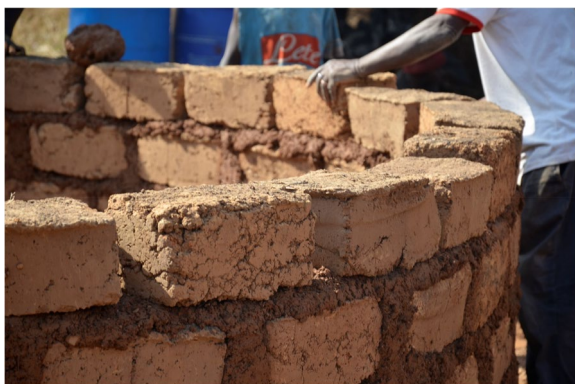
Fig. 4 A man demonstrating the construction of a building using sundried earth bricks and earth mortar joints in Wa (Source: the authors, taken in 2021)
